PHASE 1 NEEDS ASSESSMENT

Phase 1 Needs Assessment Study
for
APPANOOSE COUNTY SERVICE AGENCY
Centerville, Iowa

August 13, 2015

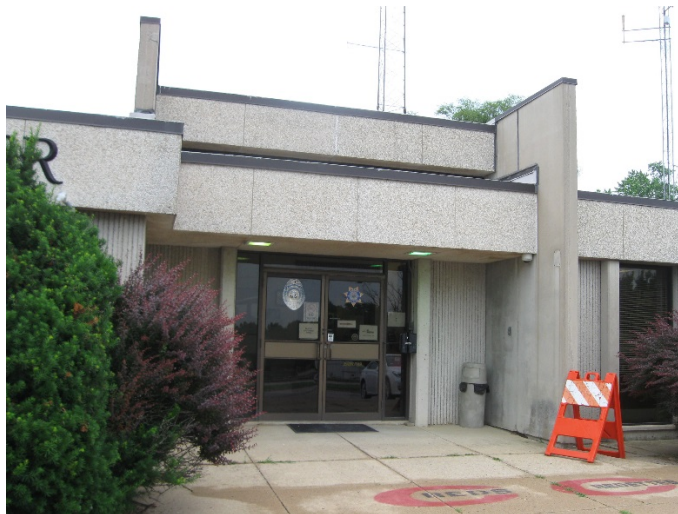
Figure 13 (Main Entrance)

The existing Jail was designed and constructed before minimum jail standards were codified in Iowa's Administrative Code, in 1982. These standards were enacted to lessen the potential for successful litigation against local officials in response to lawsuits by inmates. Most facilities built prior to the adoption of the standards are considered "grandfathered" and therefore not subject to the current minimum standards. However, all renovations or new construction are now required to meet the Minimum Standards; a difficulty compounded by a facility built prior to 1982 and one with a pre-cast concrete structure. (Figure 13)

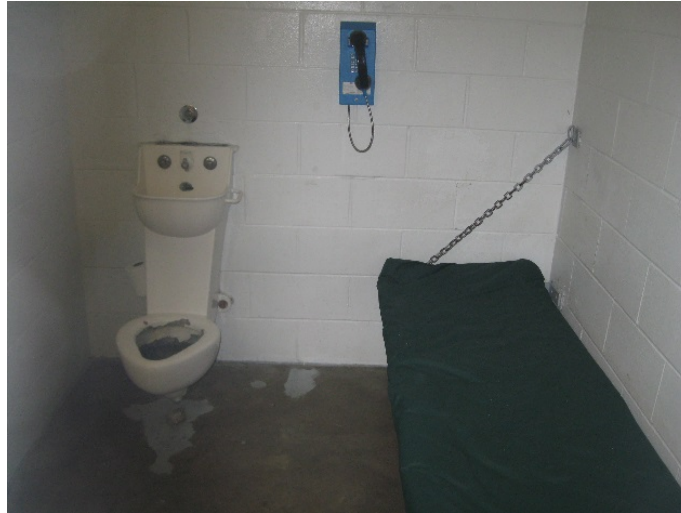
Figure 14 (Bunk Beds in Cell)

- **Failing Plumbing Systems:** *The Jail has a failing plumbing system which is in need of constant maintenance. Pipes are constantly developing leaks and are filled with corrosion, water temperatures & pressures are inconsistent & need constant adjustment and plumbing fixture age & quantity are inadequate for the housing of prisoners. Only 3 showers are available for all inmates housed in jail, requiring that correction officers to rotate inmates through cells with showers. Also, the plumbing fixtures are out of date, making it more difficult to obtain replacement parts (Figure 14).*

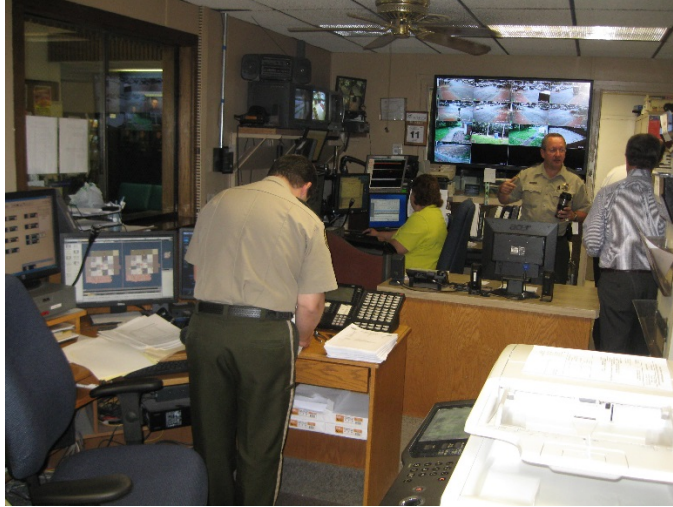
Figure 15 (Master Control & Communications Center)

- **No direct line of sight to housing units or holding cells:** *Corrections officers rely on a video surveillance system to monitor prisoner activities in real time. This creates potential security risks in areas where cameras do not reach. It also potentially increases the county's liability if something unfortunate should happen (suicide, for example) within view of the surveillance camera, yet missed by the master control staff (Figure 15).*

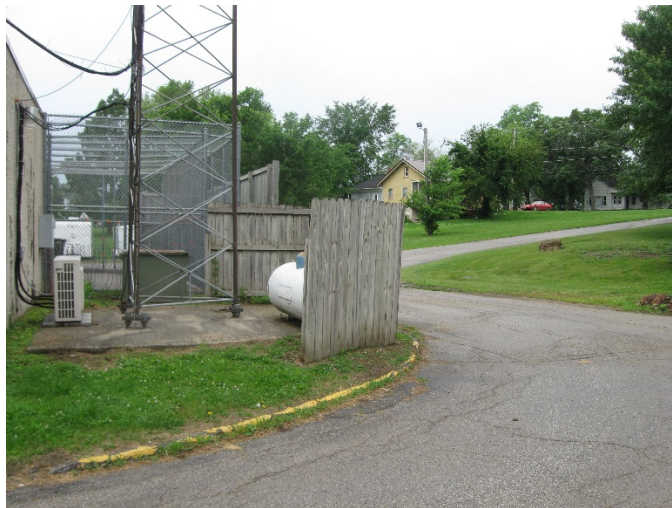
Figure 16 (Outside Exercise w/Alley & Residential Neighborhood)

- Proximity to the public and contraband: *The exercise area is at the back of the jail and is exposed to the alley that separates the existing jail facility from a residential neighborhood. This space is a constant source of concern as it provides opportunity for the inmates to interact with persons outside the jail and as a possible means of contraband entering the facility (Figure 16).*

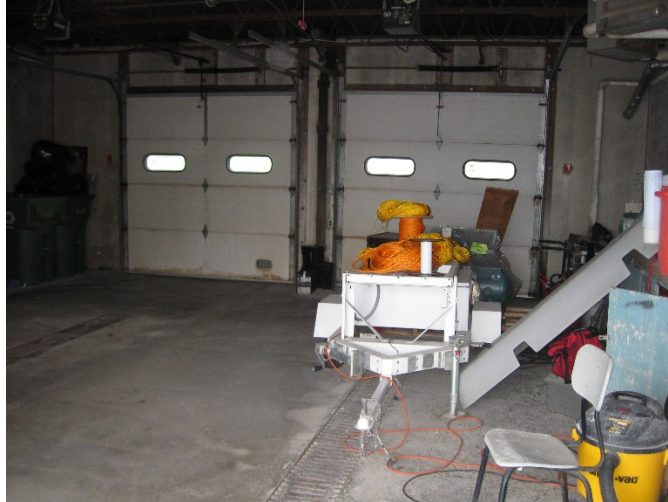
Figure 17 (Sallyport & Storage)

- Garage doors are too narrow to easily accommodate current vehicle sizes. *Vehicle damages regularly occurs due to small garage door size.*

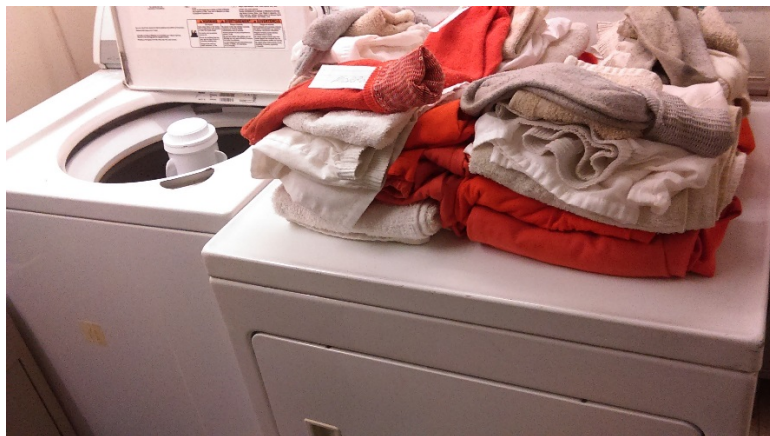
Figure 18 (Laundry)

- Not sized for commercial use: *The existing laundry space cannot house commercial fixtures and therefore relies on residential units not designed for this level of use. It is typical for washers and dryers of this type to last only 12 to 18 months after processing up to 10 loads per day. Furthermore, there is not enough space to process and fold clean laundry; nor is there space to accommodate all the jail-issue storage that is currently housed near the laundry (Figure 18).*
- Washer backs up 3-4 times per year due to the poor condition of the plumbing system, which is failing.

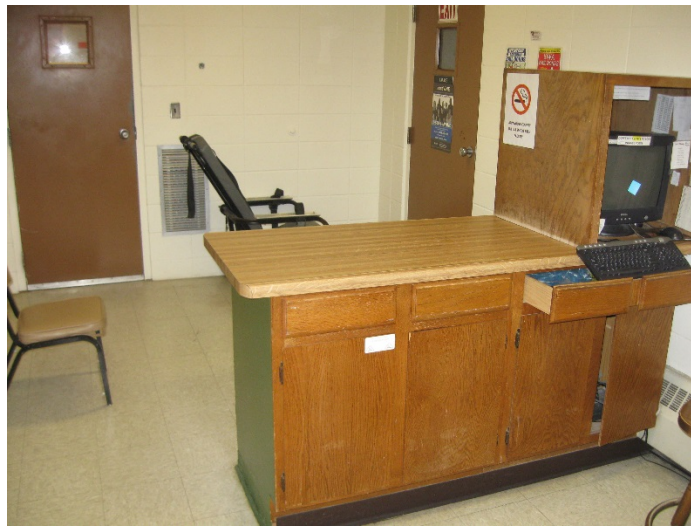
Figure 19 (Booking Station)

- No Holding Cell in Proximity: *There is no holding cell in proximity of booking, to securely hold and monitor inmates during the booking process, which complicates processing multiple arrestees into the jail. (Figure 19).*

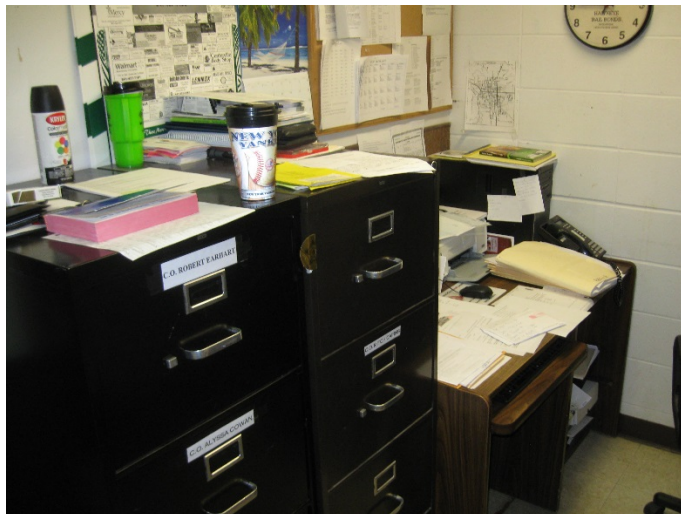
Figure 19 (Jail Deputies Office)

- Insufficient space: *Currently 3 deputies share a former hearing room which has been converted to a split use space of video monitoring, 2 desks and file storage (Figure 20).*

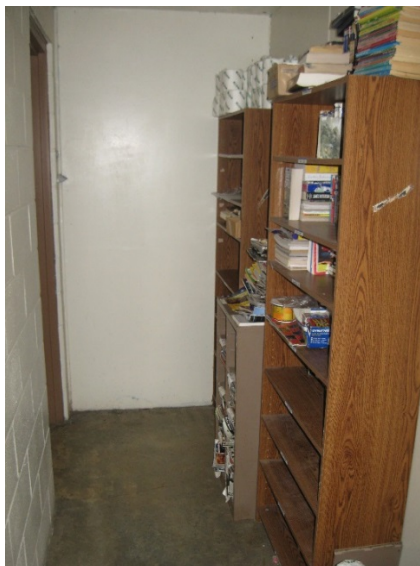
Figure 20 (Secured Corridor)

- There is currently no dedicated space for a Multi-Purpose Room: *Library books are currently stored on wood shelving along a secured corridor. (Figure 20)*

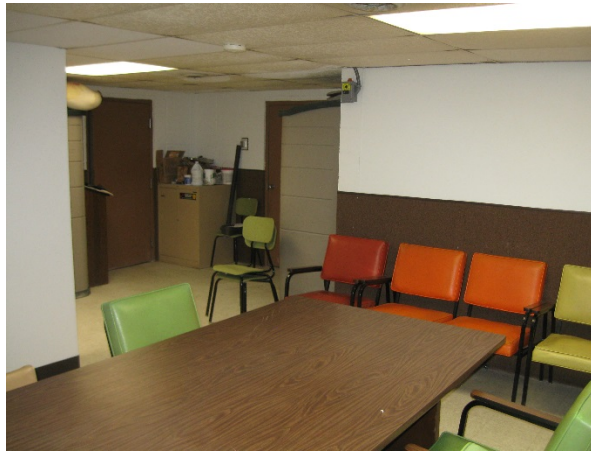
Figure 21 (Flex / Gathering Space)

- No public gathering space: *In the immediate aftermath of a significant event, the Sheriff's Office is inundated with family, witnesses, professionals, first responders, etc. and has no area to safely gather these individuals. Also, with the lack of space, there is limited additional space to keep individuals separated, if required.*

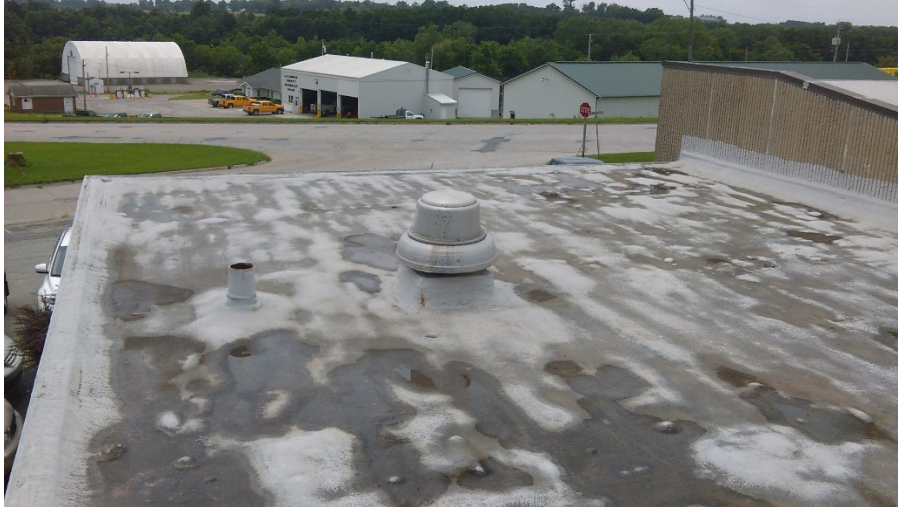
The useful life of most buildings is 30-40 years, at which time most building systems require significant maintenance, repair or replacement. Most systems, such as roofing system (Figure 22), plumbing systems, mechanical systems, reach the end of their life-cycles after only 20 years. In other cases, the buildings themselves become dysfunctional or non-compliant due to changes in codes and regulations, or become undersized due to growth of services. The current ACSA Law Center is experiencing all of these conditions.

Figure 22 (Law Center Roof Failing, Spray-On Polyurethane system 'Bubbling' or Lifting from substrate)

- It was noted that the high roofs over the main lobby and jail simply drain onto the lower roof area. Yet, only two primary roof drains are available on the lower level roof to collect storm water.
- Severe bubbling of the spray-on polyurethane foam insulation has affected roof drainage patterns to the limited number of roof drains that exist. As a result, water was found ponding on the roof in many areas
- Though the roof over the garage has its own primary roof drain, water ponding is occurring on the northern end.
- No clear means for secondary roof drainage systems was found.
